A REVIEW OF MOSQUITO CONTROL OPERATIONS
IN MASSACHUSETTS WETLANDS

REGULATORY BRANCH, NEW ENGLAND DIVISION
U.S. ARMY CORPS OF ENGINEERS

Robert J. DeSista
Charles J. Newling
1979

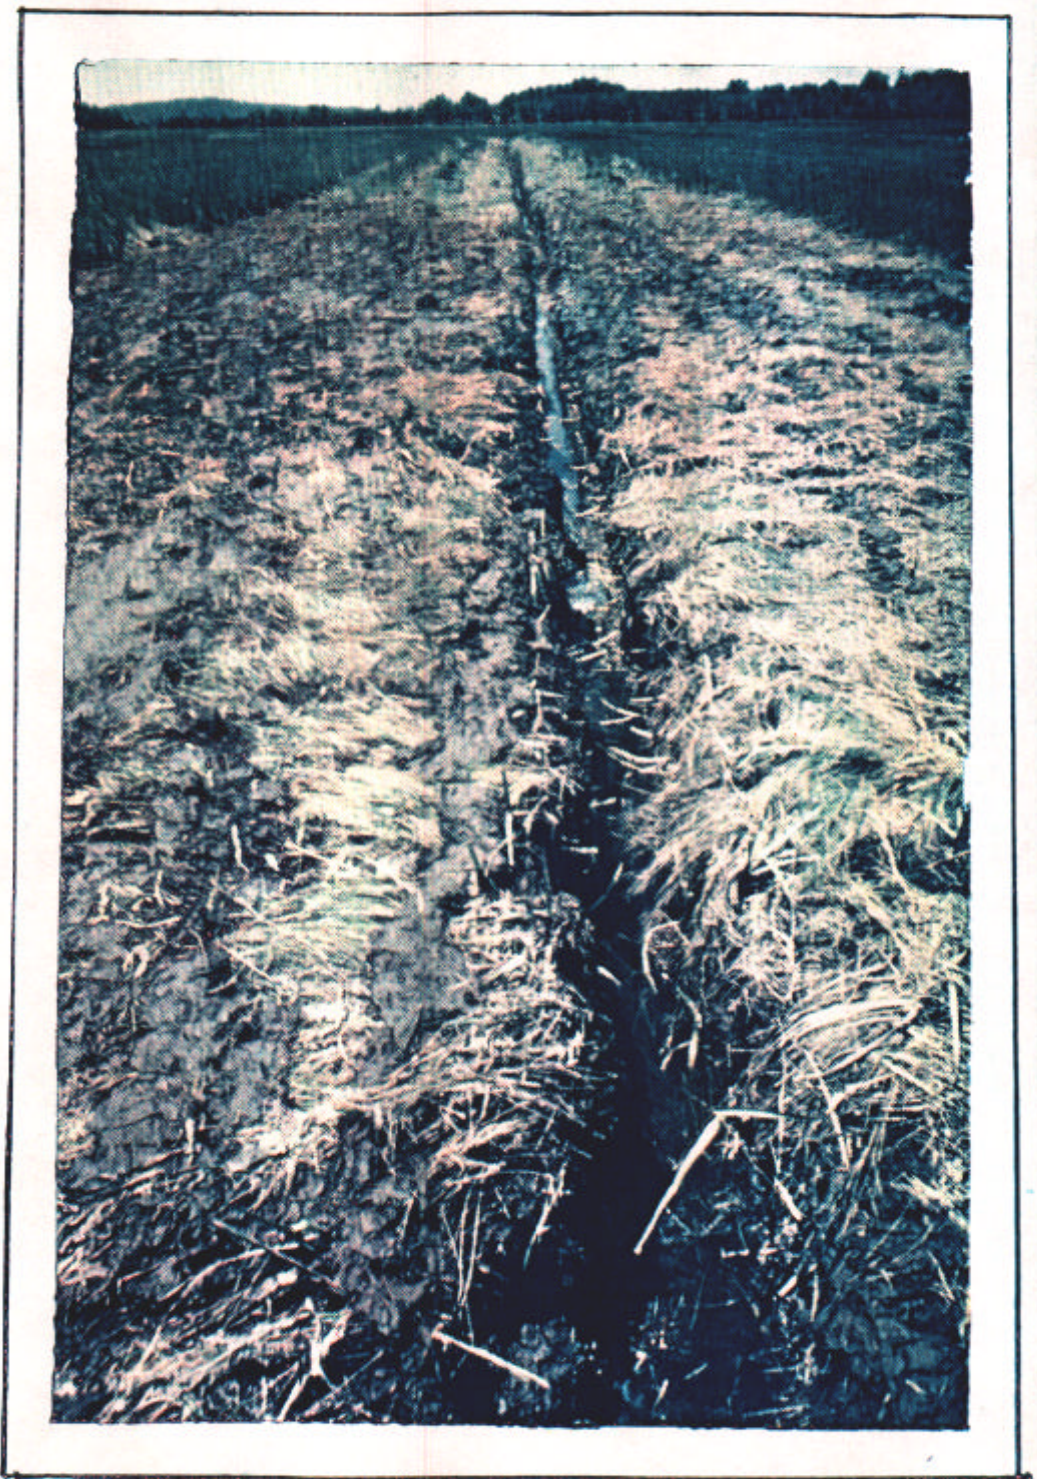
(Fig. 18) Ditch cleared 1 week earlier by scave
plow with spoil bladed level and scraped to edge
of marsh by bulldozer. (Newbury, Mass. 28 June 1978.

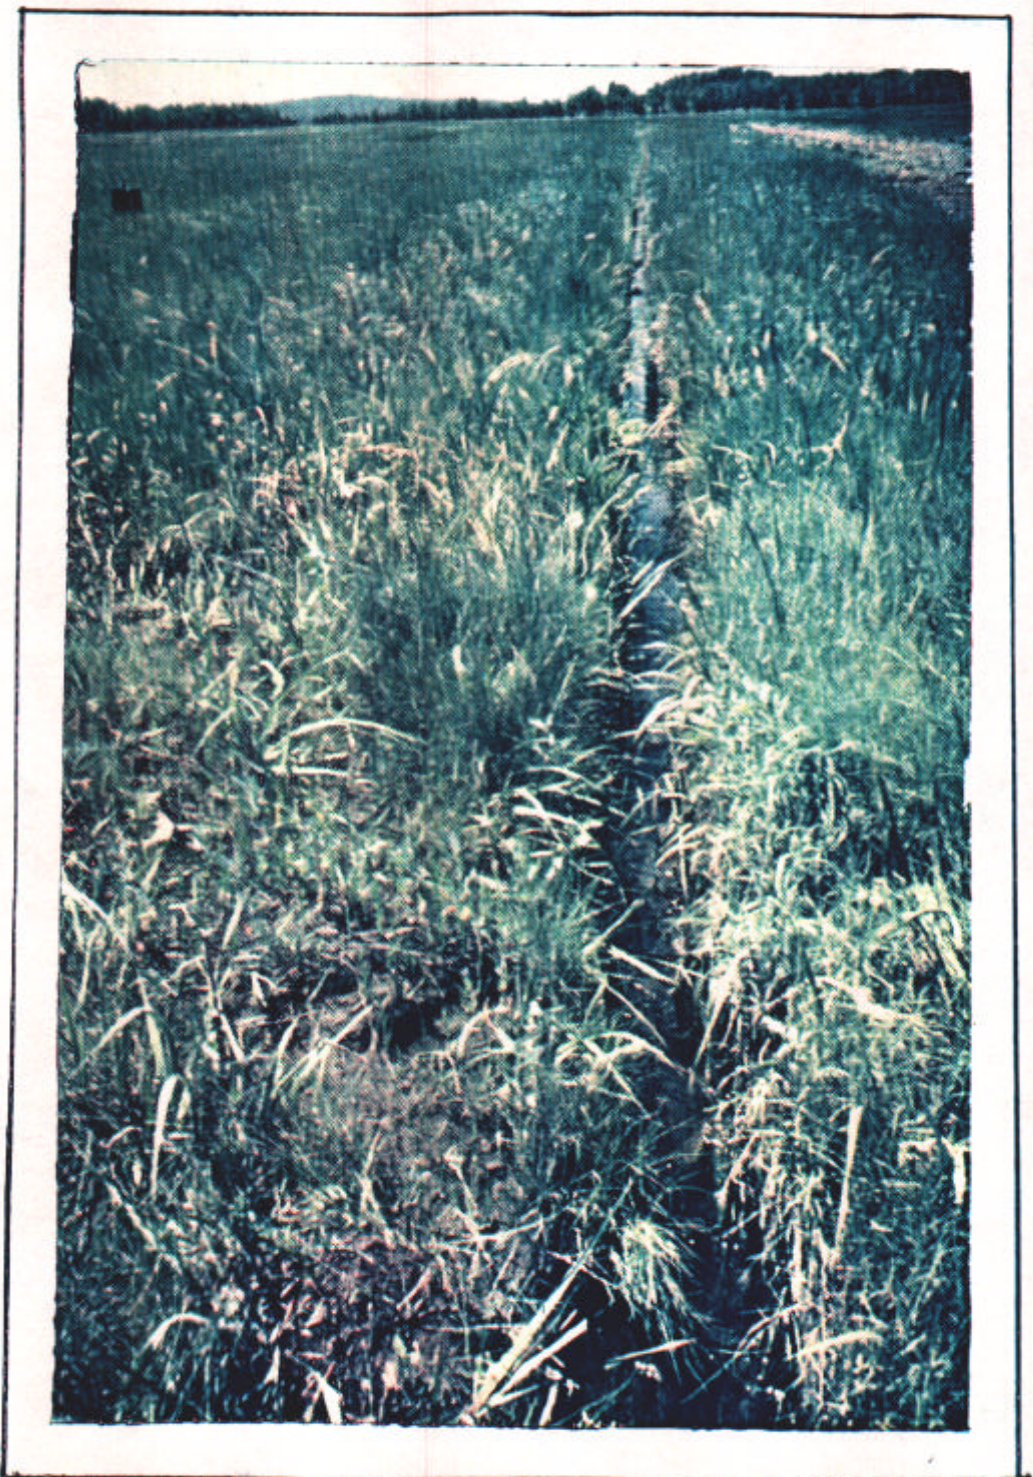
(Fig. 19) Regrowth after one year on saltmarsh along a ditch scavel-plowed with spoil bladed level and scraped to edge of marsh by bulldozer. (Newbury, MA. 28 June 1978.)

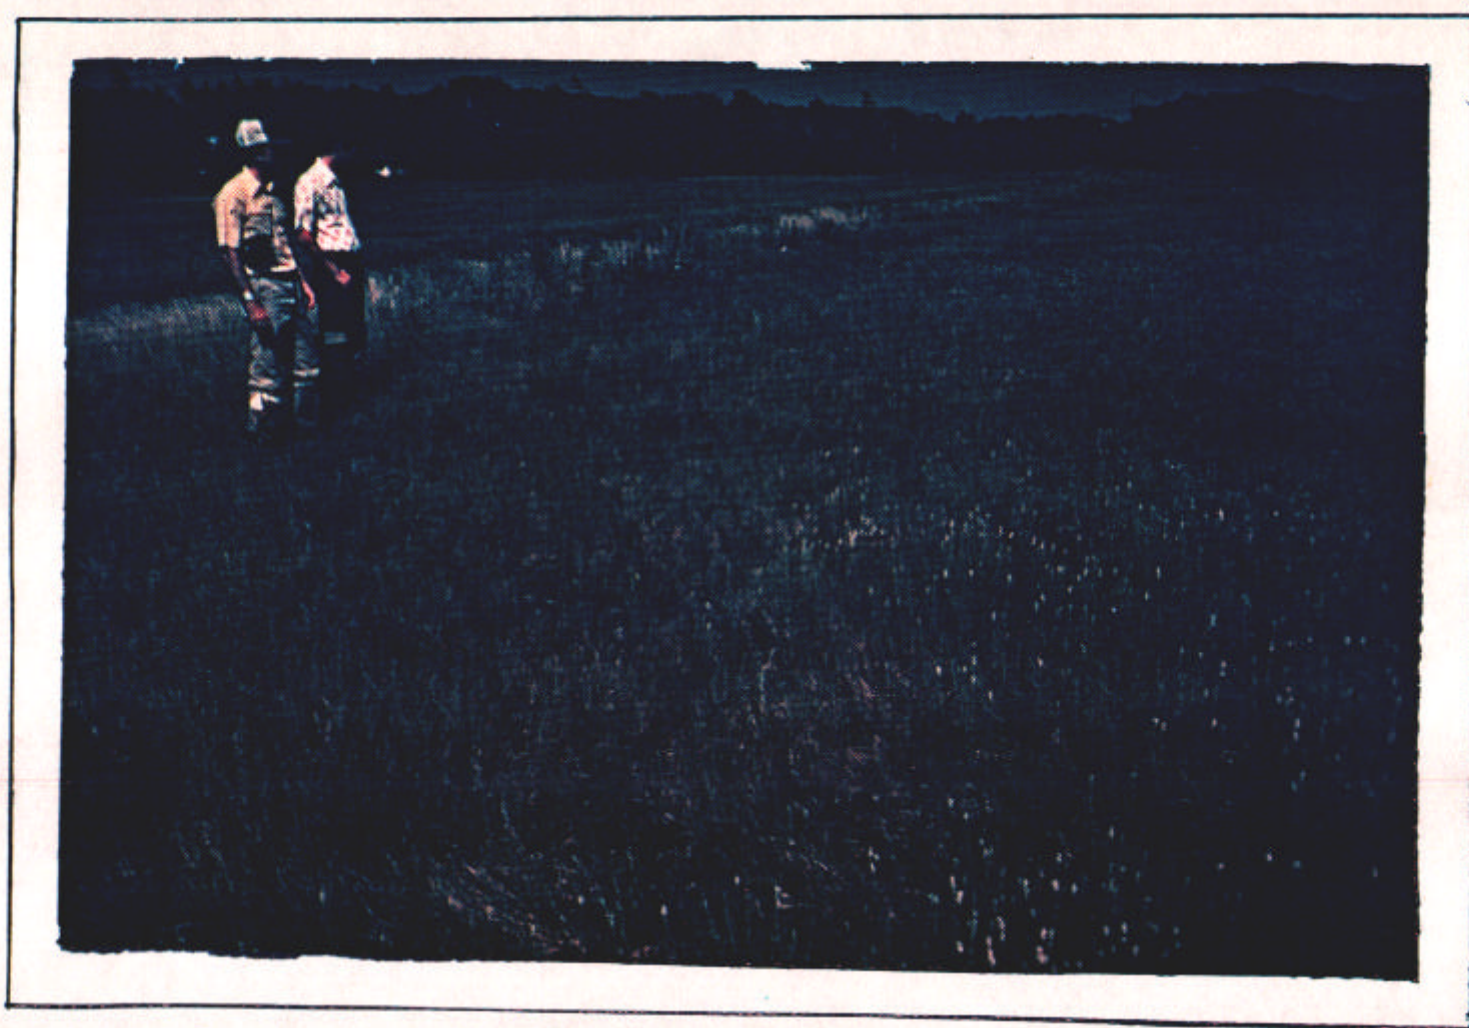
Figure 20) In this area of minimal tidal influence, a continuous spoil pile, (background) resulting from a past ditch clearing operation, acts as a dam retarding surface drainage. Breeding conditions have been created by the formation of a shallow, stagnant pool obscured from view by the patch of alkali grass (*Distichlis Spicata*) in the central portion of this photograph. (Onset, MA. 14 August 1978).

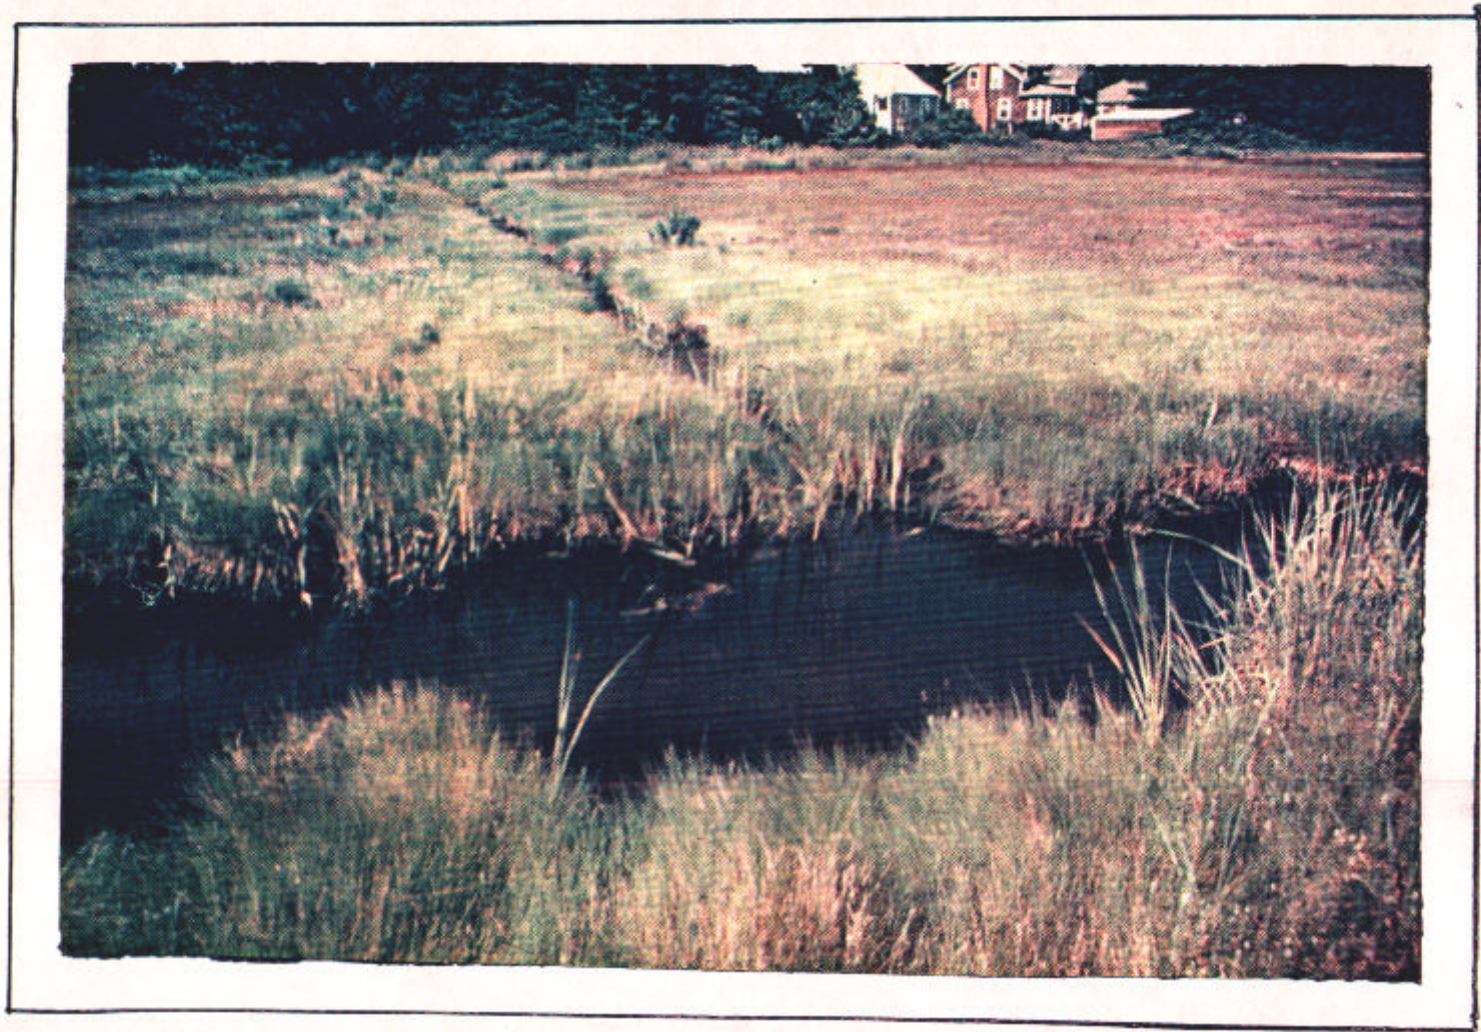
(Fig. 21) In areas with minimal tidal influence, invasion by tolerant upland species can occur. On this spoil deposit, the plant community is essentially that of a tidal marsh, however, occasional specimens of upland species such as common ragweed (Ambrosia Artemisifolia) can be found. (Onset, Mass. 14 August 1978.

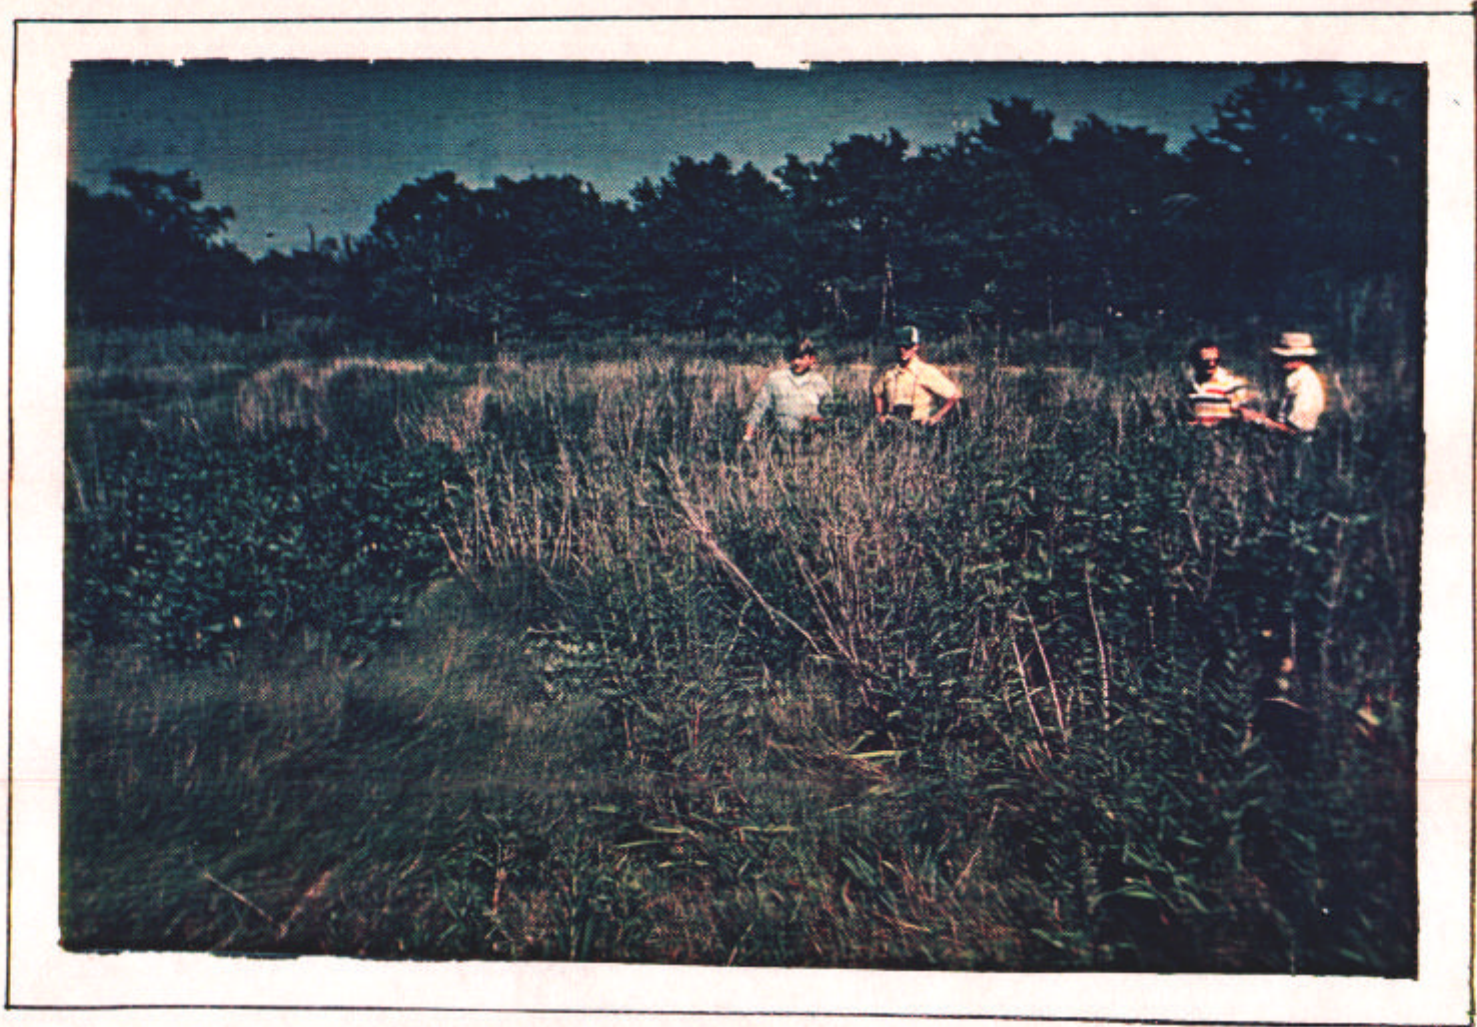
(Fig. 22) Heavy growth of the woody plant, marsh elder (*Iva frutescens*) around ditch cleared 7 years earlier in upper estuary. Marsh elder was most abundant at edge of ditch itself and on the original marsh surface not covered by spoil; it appeared to be less abundant or absent from the clumps of spoil themselves. (Wareham, MA. 14 August 1978).

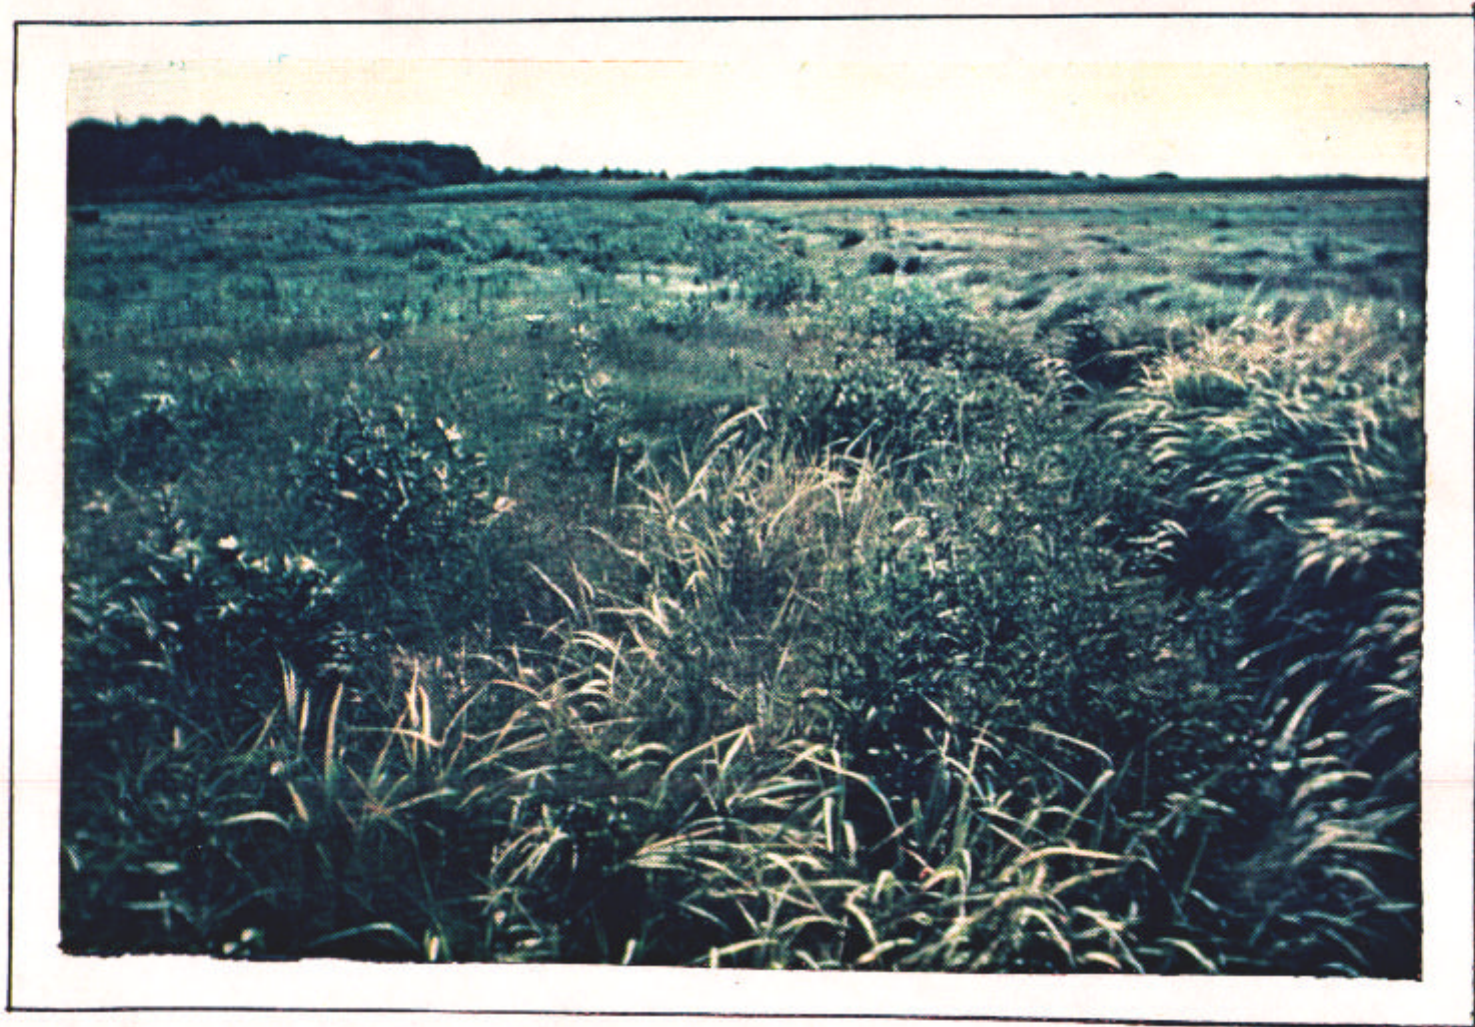
On the Barnstable Marsh on Cape Cod, we observed another situation involving freshwater influx on a saltmarsh. Here a ditch paralleling the upland edge was apparently carrying off water heavily influenced by upland influx of fresh water (Figure 23).

(Fig. 23) Ditch parallels upland edge of marsh. Note heavy growth of broadleaf saltmarsh plants, primarily Seaside Goldenrod (*Solidago sempervirens*), to upland side (right) and conspicuous absence of these plants to the seaward side (left) of ditch. Ditch may be carrying off surficial flow of fresh water creating differing environment for the plant community of either side of the ditch. (Barnstable, Ma., 25 July 1978).

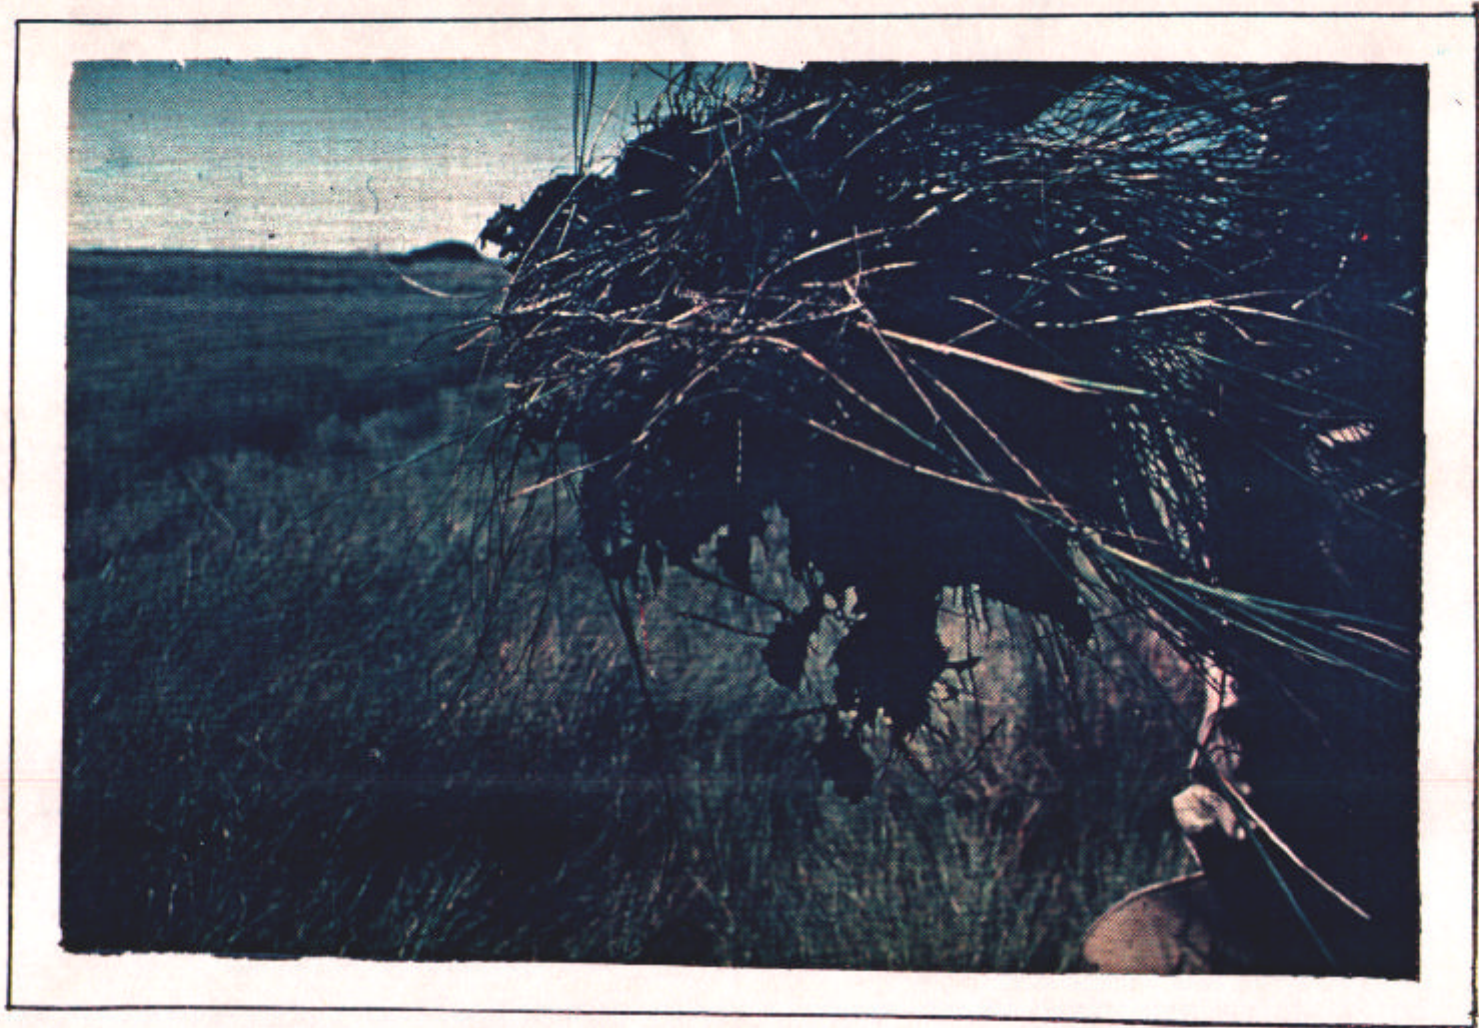
Saltmarsh sod displayed some resiliency to environmental insult. Spoil, including sod, seemed to be recolonized extremely rapidly by salt-marsh plants. Several times we found clumps of salt meadow grass which had taken root and continued to grow where it was dropped as long as it was placed with the roots down (Figure 24).

(Fig 24) New roots protruding from a clump of salt meadow grass (*Spartina patens*) which had been recently deposited (roots down) on a salt marsh after hand clearing of a clogged ditch. (Fairhaven, Mass., 18 August 1978).

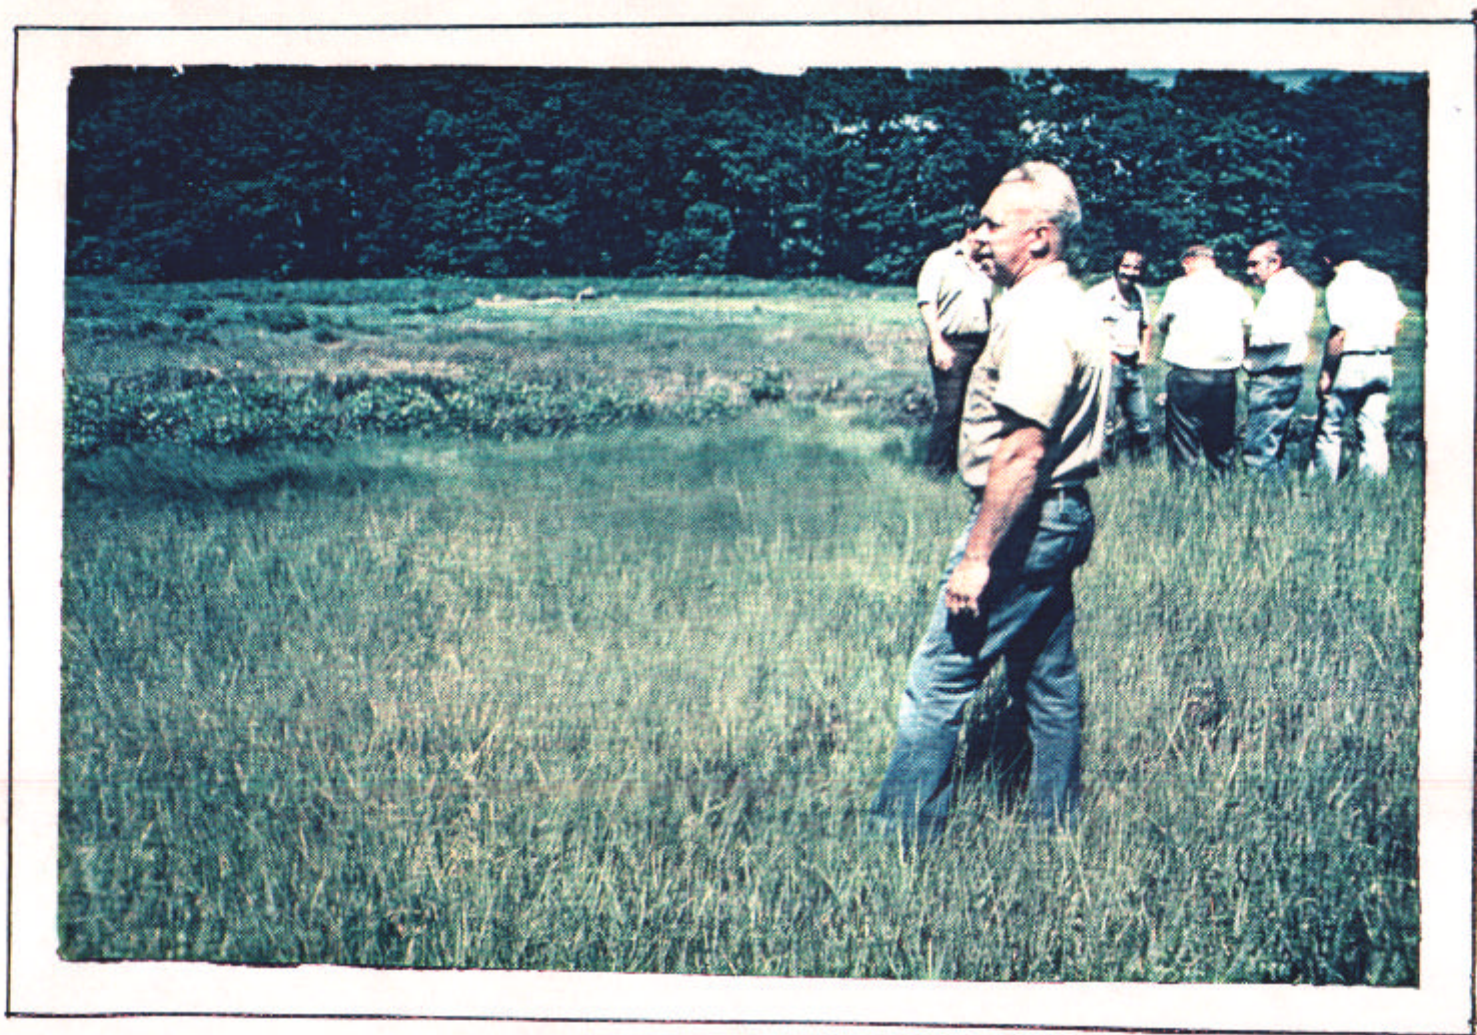
In Essex County, we observed another interesting phenomenon. Ten years earlier, a shallow salt pan (pool) had dewatered as a result of a clearing operation on a ditch located 10 meters away. One year later, the formerly "barren" area was thickly covered with glasswort (Salicornia sp.). The second year, and for all the years following the area succeeded to the short form of saltwater cordgrass (Spartina alterniflora (Figure 25).

(Fig. 25) After a nearby ditch had been cleared 10 years earlier, this "salt pan" area (foreground) dewatered and succeeded to Spartina Alterniflora short form. (Newbury, Mass. 28 June 1978).
